November 2023

Subject: Sweetgum assessment
37 Mesa Ave. on Park Way

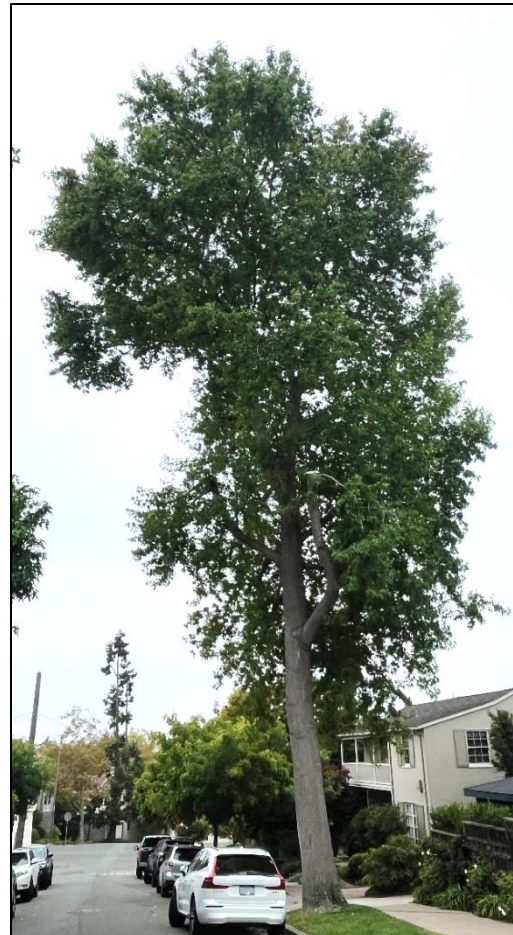
Photos 1. The sweetgum was pruned on October 18th leaving few branches on the street side.

Pruning of these three limbs created the one-sided crown (Photo 1). Additional removal and reduction pruning would likely compromise crown structure.

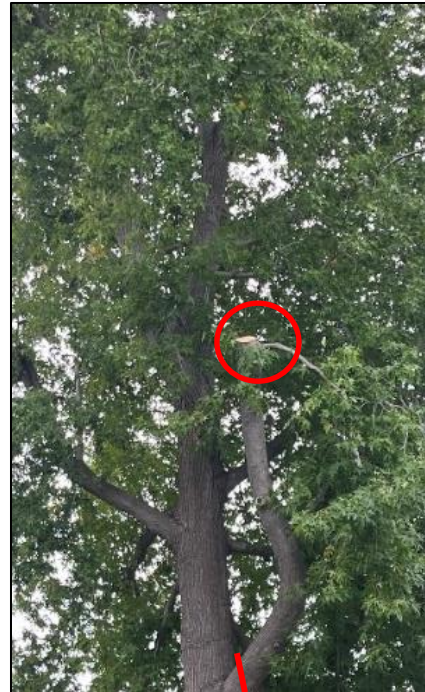
Three limbs were pruned: 1) the branch from which the October 2023 failure originated, 2) a partially attached branch that was resting on top of another limb, and 3) a structurally unsound limb with decay was reduced (Photo 2) with a heading cut. Neither branch #2 nor 3 were visible from the ground.

Photos 2. Branch that was headed should be removed further raising the lowest branch.

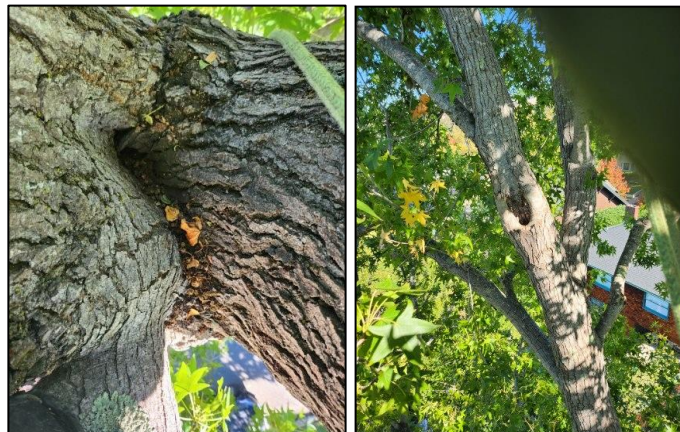
The climber also identified several branch unions with included bark and at least one cavity (Photos 3 and 4). These defects were not addressed in the October 18th pruning. But should be addressed if the tree is going to be preserved.

Photos 3 and 4. Two examples of cavities were identified by the climber. Cavities create weak points along the branch.

Based on current structural condition and the history of failure, I recommend removal of the tree. Additional pruning would further compromise the structural integrity. Decay will only worsen, increasing the likelihood of failure over time. Removal and replacement is a prudent management option.
