October 25, 2023

Subject: Sweetgum assessment
416 Park Way

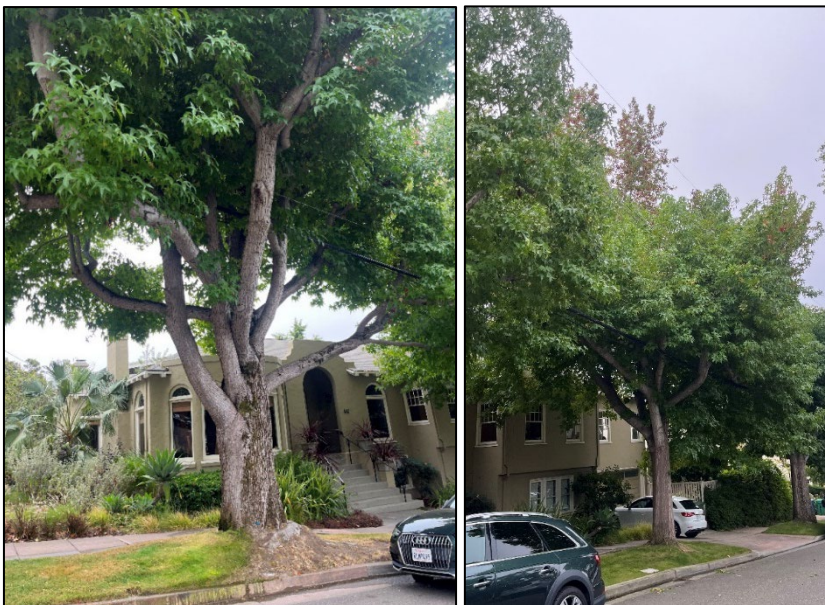
Lateral branches of tree #99 turned upwards to form a candelabra shape (Photo 1). Branch attachments were narrow, crossing, and were poorly formed. A large girdling root was present extending a third of the way around the tree.

Photo 1. Tree #99 was close to the southwest corner of Park Way and Masa Ave. Lateral branching was poorly formed turning upright.

I recommend retaining trees #98 and 99. Prune both trees with the goal of removing dead, broken, crossing, and weakly attached branches, and reducing the end weight of branches over the home. These trees should be inspected on the standard City inspection cycle.

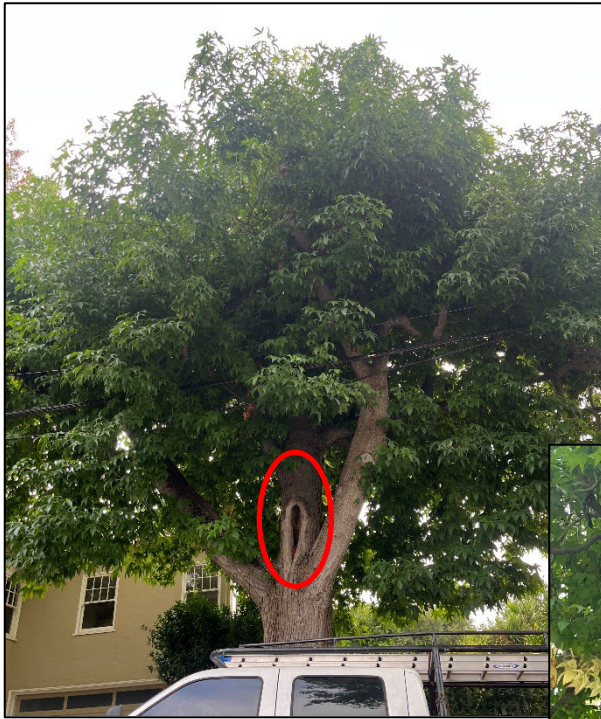
Tree #98 had a 21-inch diameter trunk, the smallest of the group. It appeared to have stronger, wider lateral branch attachments (Photo 2) than the other two trees. Large, heavy limbs extended over the house.

Photo 2 (middle). Branching of tree #98 had fair structure.

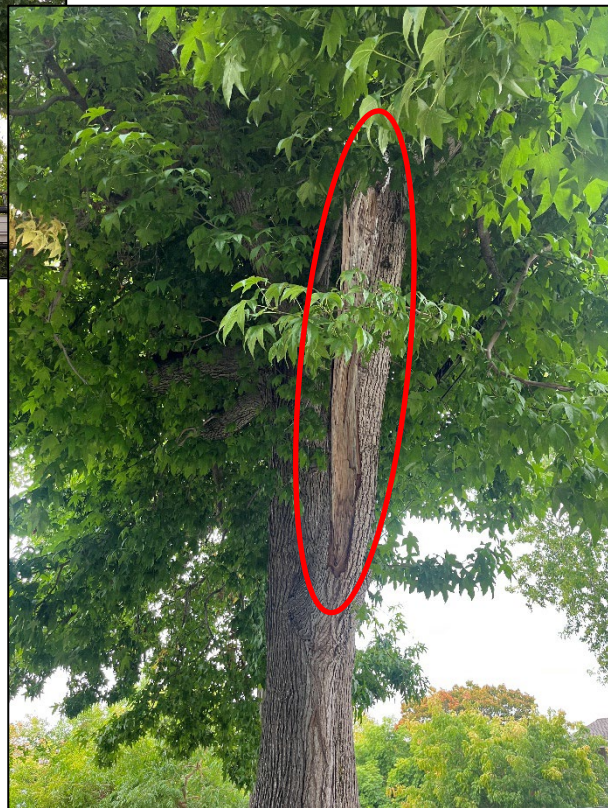
Tree #97 had a cavity with decay on the street side (Photo 3, next page). A 12 ft. long wound was present on the house side, resulting from the failure of a scaffold branch (Photo 4, next page). Response growth indicated the presence of internal decay, potentially extending into the main trunk.

Photo 3 (left). Tree #97 had a cavity with decay on the street side.

Photo 4 (below). A 12 ft. tear down wound was present on the east side of tree #97.

I recommend removal of tree #97. The tree had poor structure and a history of branch failure resulting in decaying cavities and wounds. I am not aware of any arboriculturally sound treatment or techniques to further mitigate these defects without compromising the tree's structure. The tree's condition will not improve. Decay will only worsen, increasing the likelihood of failure over time. Removal and replacement is a prudent management option.
