COASTLAND

RE: Piedmont Pathway Inventory

**Table 1. Pathway Repair Inventory
City of Piedmont
November 2019**

**Table 2. Pathway Repair Photo Log
City of Piedmont
November 2019**

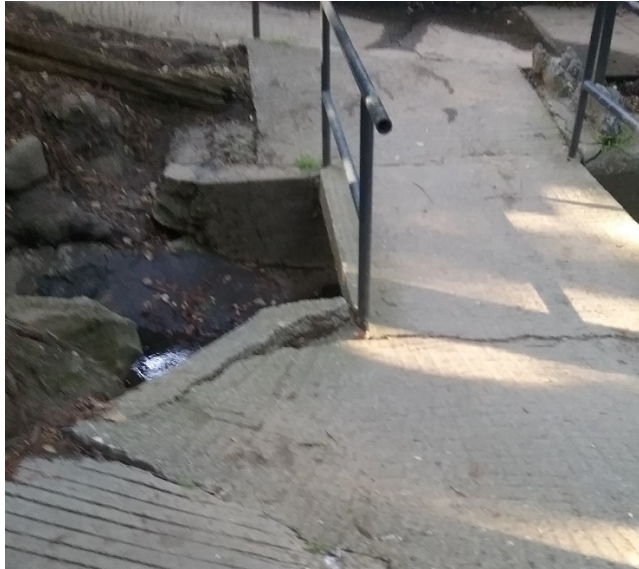
Bridge Replacement. A small concrete bridge in Piedmont Park is recommended for replacement. There are options for replacement including, but not limited to a pipe arch bridge (sometimes known as ConSpan) or culvert.

View of concrete bridge in Piedmont Park to be replaced (Project 36M)

Replacement costs for the bridge will need further investigation and will need to take into consideration potential environmental impacts.

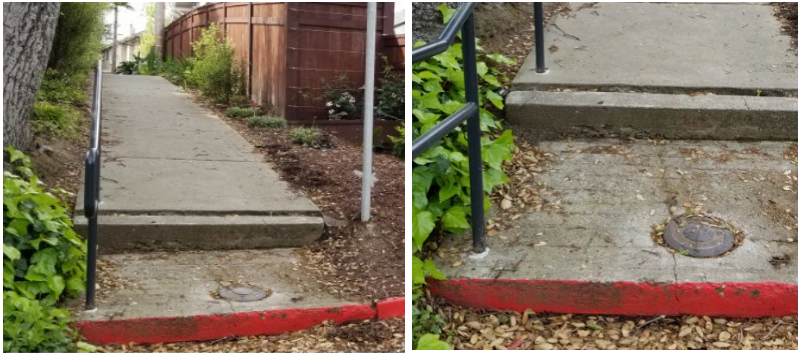
10A	Boulevard Way to Sylvan Way Walkway	conc step	D	136	6	Step has separated from walkway caused by tree root	Grind conc path above top step	1	EA	\$150.00	\$150	1
11A	Coaches Playfield	conc s/w	C	1043	6	Broken panel	Grind conc	1	EA	\$150.00	\$150	1
11B	Coaches Playfield	conc s/w	C	1043	6	Uneven conc panel	Grind conc (2")	1	EA	\$150.00	\$150	1
12	Crocker Park Walkways	conc s/w	A	121	4	Good condition	None					
12A	Crocker Park Walkways	AC path	C	698	4	Cracks, uneven surface	Replace AC path (698'x4')	2792	SF	\$4.59	\$12,815	1
13	Dracena Quarry Park	Conc path	A			Good condition

9A	Blair Ave to Scenic Ave Stairway	Replace panel (6'x5')	No photos taken
9B	Blair Ave to Scenic Ave Stairway	Remove and replace stair curb (30'x0.5'x1.5')	No photos taken
10	Boulevard Way to Sylvan Way Walkway	None	No photos taken
10A	Boulevard Way to Sylvan Way Walkway	Grind conc path above top step

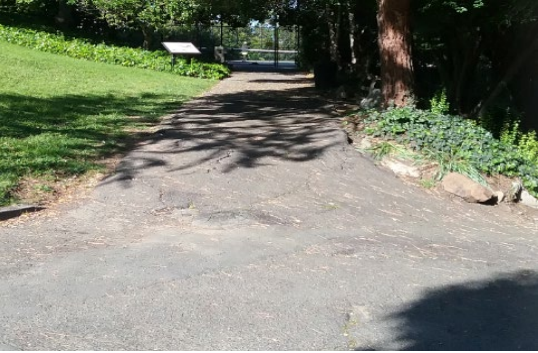
36B	Piedmont Park & Exedra Plaza: Path #8	AC walkway	D	131	8	Cracked, uneven pavement	Replace AC pavement (40'x8')	320	SF	\$4.59	\$1,469	1
36C	Piedmont Park & Exedra Plaza: Path #9	AC vehicle access	C	100	20	Cracks and potholes	Replace AC pavement (100'x20')	2,000	SF	\$4.59	\$9,180	2
36D	Piedmont Park & Exedra Plaza: Path #10	conc/brick walkway	C	243	varies	Cracks in concrete, broken panels	Replace conc/brick path (~30'x30')	900	SF	\$20.00	\$18,000	3
36	Piedmont Park & Exedra Plaza: Path #11	conc path	B	226		Good condition	None					
36	Piedmont Park & Exedra Plaza: Path #12	stone steps	B	50		Good condition	None					
36E	Piedmont Park & Exedra Plaza: Path #13	conc path	C	103	5	Broken concrete	Replace concrete (16'x5')	80	SF	\$20.00	\$1,600	1
36F	Piedmont Park & Exedra Plaza: Path #14	AC vehicle access	B	104	14	Minor cracks, no separation	Slurry seal AC pavement (104'x14')	1456	SF	\$1.00	\$1,456	3

36B	Piedmont Park: Path #8	Replace AC pavement (40'x8')
