## DRAFT TECHNICAL LETTER

Moraga Avenue S-Curve Improvements in Piedmont, California

Date: January 9, 2015 Project #: 18507  
To: John Wanger, PE  
From: Jorge A. Barrios, PE; Erin Ferguson, PE  
cc: Mark Bowman, PE

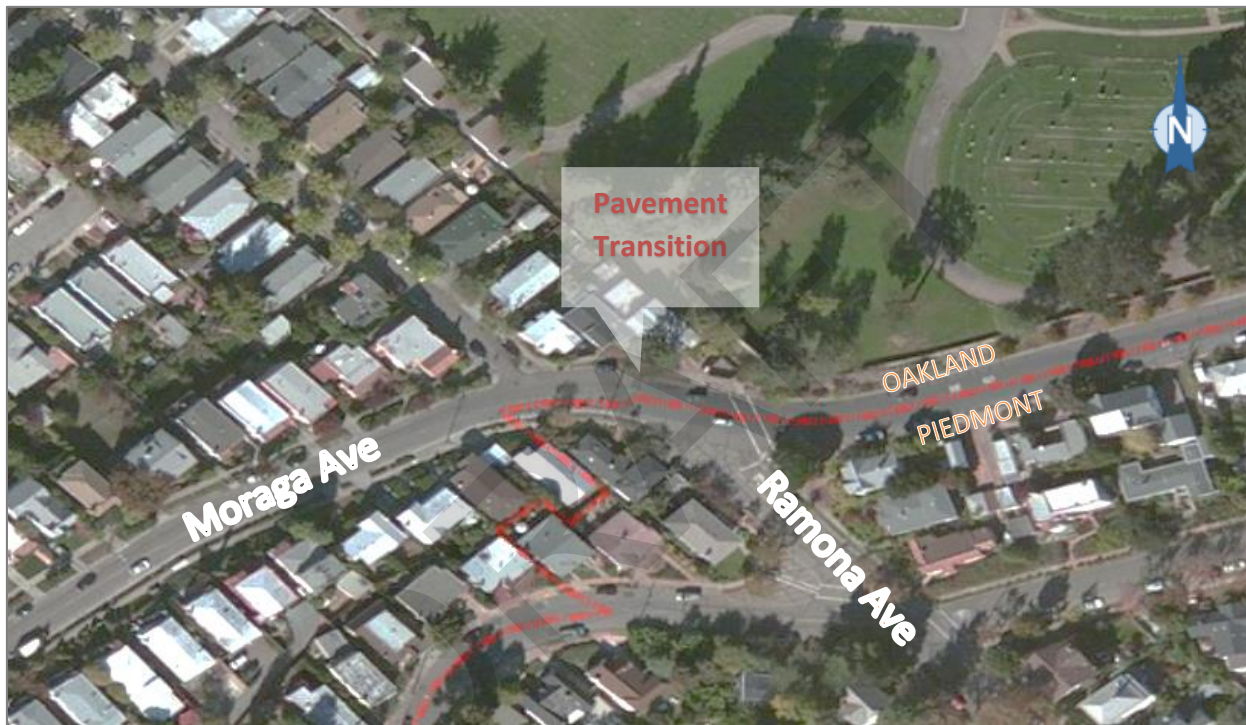
**Figure 2: Project Location**

Moraga Avenue is a two-lane undivided east-west arterial on the northern border of the City of Piedmont. It is one of four streets that form the backbone of Piedmont's circulation system, according to the City of Piedmont Pedestrian and Bicycle Master Plan (the other three streets are Grand Avenue, Highland Avenue, and Oakland Avenue). Ramona Avenue is a two-way residential street. Both roadways have parallel on-street parking on both sides.

At the study intersection, Ramona Avenue traffic must stop before turning right or left onto Moraga Avenue. Moraga Avenue traffic does not have to stop. An uncontrolled crosswalk is located on the east leg of the intersection, connecting a transit stop on the north side of Moraga Avenue to Ramona Avenue south of Moraga Avenue.

The KAI team performed field reviews at the study intersection on Monday, December 15, 2014 and Wednesday, December 17, 2014. The rainy weather on December 15<sup>th</sup> highlighted the differences in existing pavement condition between the City of Oakland and City of Piedmont sections of Moraga Avenue, as shown in Figure 2.

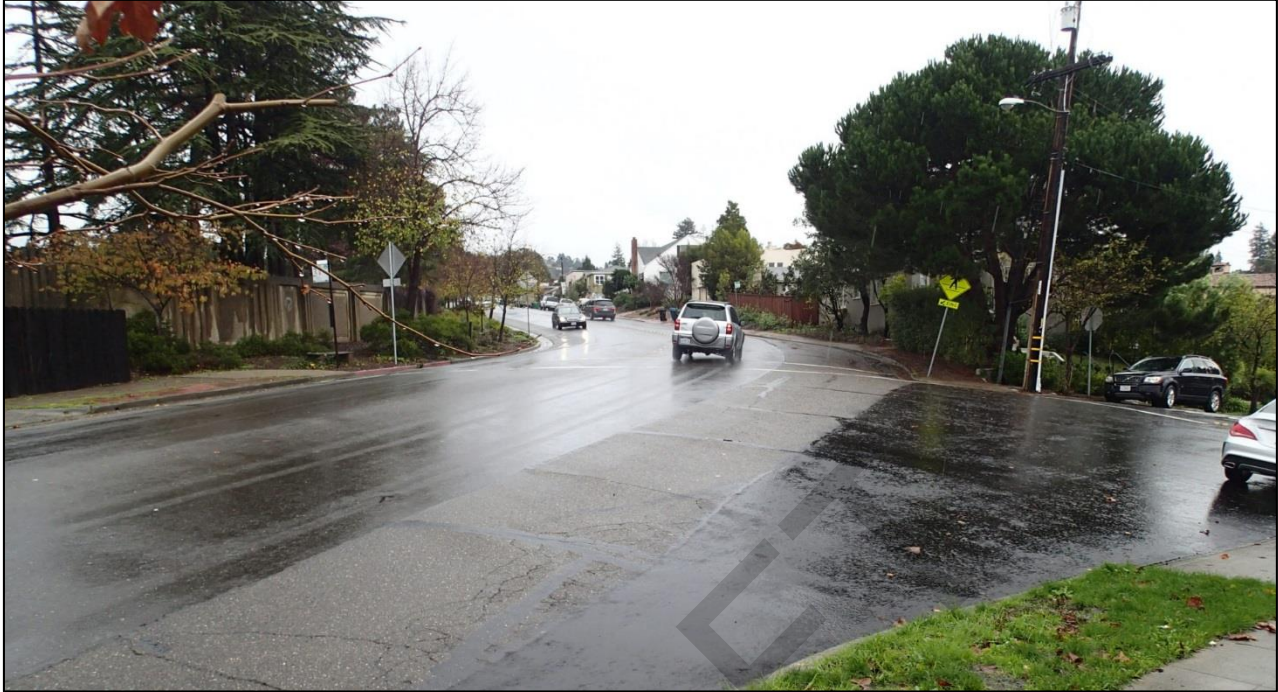
**Figure 3: Moraga Avenue, near Ramona Avenue. Facing eastbound.**

During the field visit, the KAI team also noted a relatively steep cross-slope on the south side of Moraga Avenue, dropping from the edge of the eastbound travel lane to the face of curb, as shown in Figure 3.

Applying High Friction Surface Treatment to the roadway surface will increase friction for vehicles driving through the S-curve, helping to keep vehicles within the travel lane. Flattening the cross-slope on the southern shoulder may help motorists that drift onto the shoulder maintain control of their vehicle.

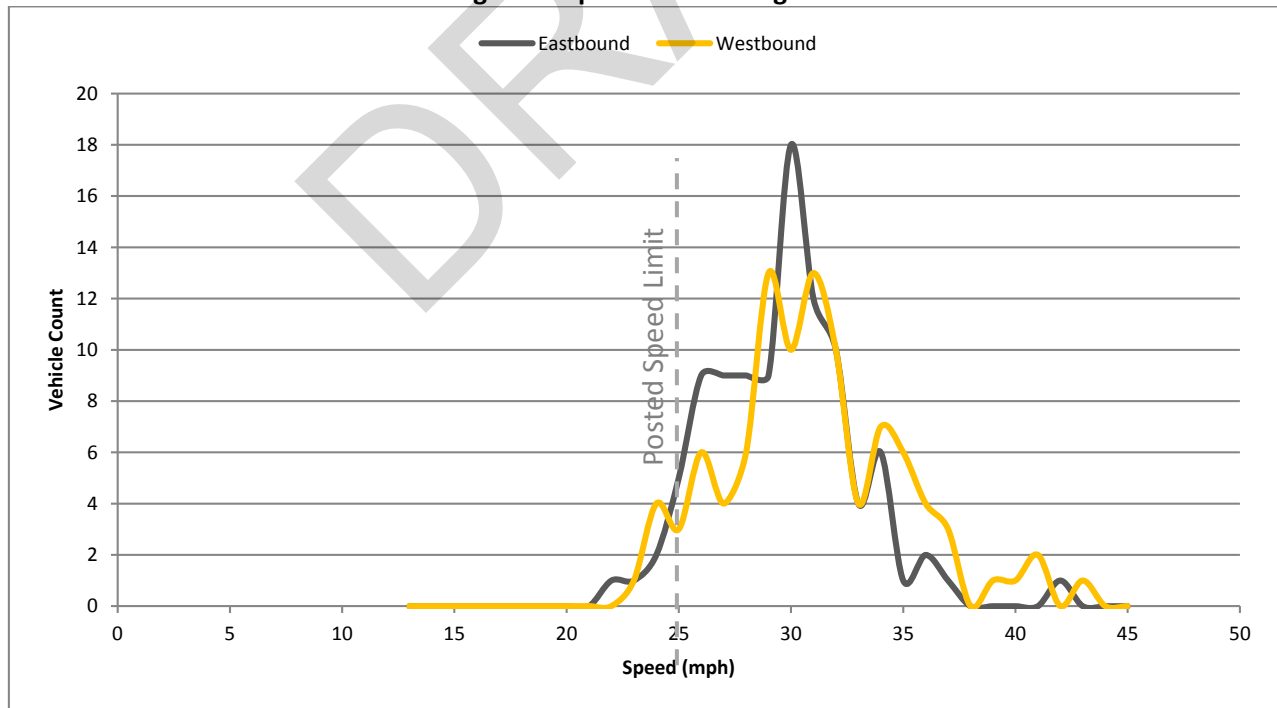
**Figure 4: Speed Data Histogram**

In the vicinity of the study intersection, the observations indicate that 84 percent of the surveyed motorists travelled in the range of 25 to 34 mph. Table 1 and Figure 4 summarize the speed data.

Speed Study Metrics	Moraga Avenue, at Ramona Avenue
Speed Limit	25 mph
Median (50th Percentile) Speed	30 mph
85th Percentile Speed	34 mph
10 mph Pace, (% of daily traffic in pace)	25-34 mph, (83.9%)

The KAI team obtained speed data through a data collection vendor. The speed data were collected on the off-peak (i.e., free-flow) hours of Monday, December 22, 2014 using a calibrated radar gun mounted on an inconspicuous vehicle as to not affect drivers' behavior. The data includes one hundred vehicles in each direction of travel on Moraga Avenue. Appendix B contains the speed data for individual vehicles.
