TECHNICAL MEMORANDUM

Piedmont Intersection Analysis

Findings and Recommendations

Date: September 5, 2018 Project #: 22905
To: George Hicks, Coastland Civil Engineering
From: Aaron Elias, Kittelson & Associates, Inc.
cc:

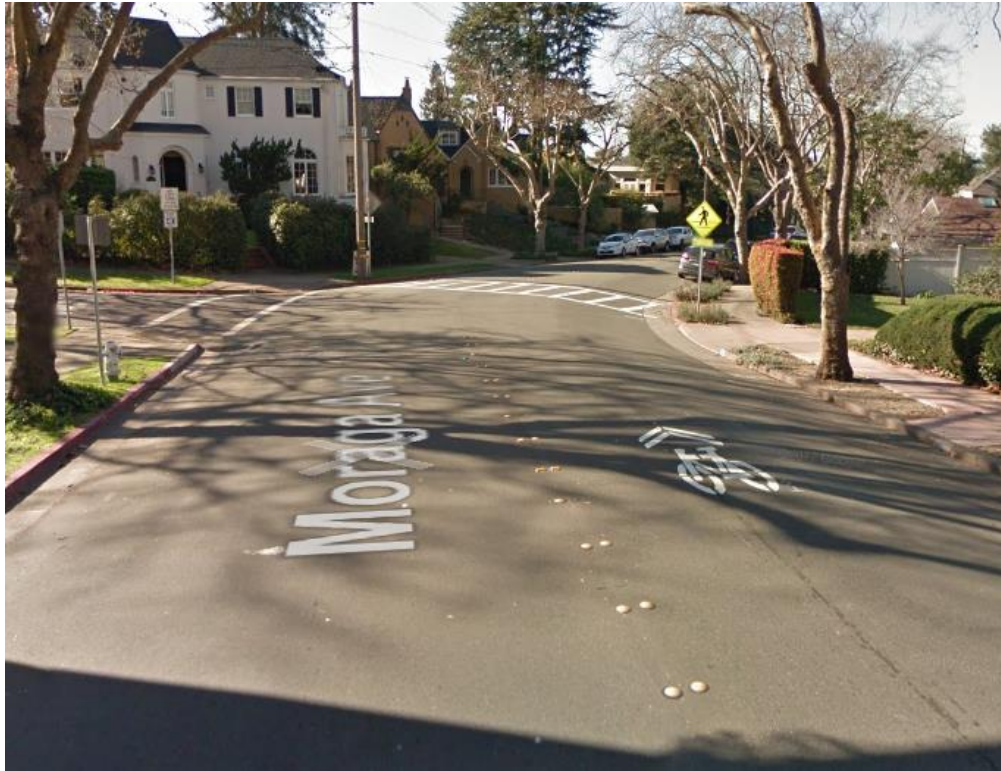
Figure 1: Intersection of Moraga Avenue and Mesa Avenue

Community concerns at this intersection were related to visibility of pedestrians in the marked crosswalk across Moraga Avenue, limited sight distance for residents exiting driveways, and collisions with parked vehicles on Moraga Avenue.

- Moraga Avenue has an abrupt horizontal curve at the intersection with Mesa Avenue. Vehicles appeared to cut the corner when rounding this curve resulting in a lack of lane discipline.
- The striping along Moraga Avenue uses pavement markers rather than painted lines reducing the centerline visibility. There are no white edge lines to define the separation between the parking and travel lane.
- While crosswalk signage is present on the right side of each approach to the crosswalk, the westbound downhill pedestrian sign may be difficult to see due to the roadway curvature. Adding another crosswalk sign (W11-2) on the left side of the road facing westbound traffic may improve visibility of the crosswalk.

- Replace the centerline pavement markers with Detail 21 striping on Moraga Avenue in the vicinity of the horizontal curve at Mesa Avenue. Detail 22 striping may also be used to provide enhanced nighttime visibility. Use Detail 41 striping to extend the centerline through the intersection of Mesa Avenue and Moraga Avenue connecting the two sides of Moraga Avenue through the horizontal curve. The striping will be more visible than the pavement markers and improve lane discipline around the horizontal curve.

- Add white edge line markings (Detail 27B) along Moraga Avenue between Pala Avenue and Bonita Avenue. This will provide additional separation between the parking and travel lane in addition to provide better guidance to drivers to better maintain lane discipline. It is recommended the edge line be maintained at about 11 feet from the centerline to provide traffic calming and to better separate parked vehicles from the travel lane.

- Add a W11-2 pedestrian crosswalk sign to the south side of the crosswalk facing westbound drivers. This sign will be better positioned in the line of sight for westbound drivers on Moraga Avenue to improve awareness of the marked crosswalk.

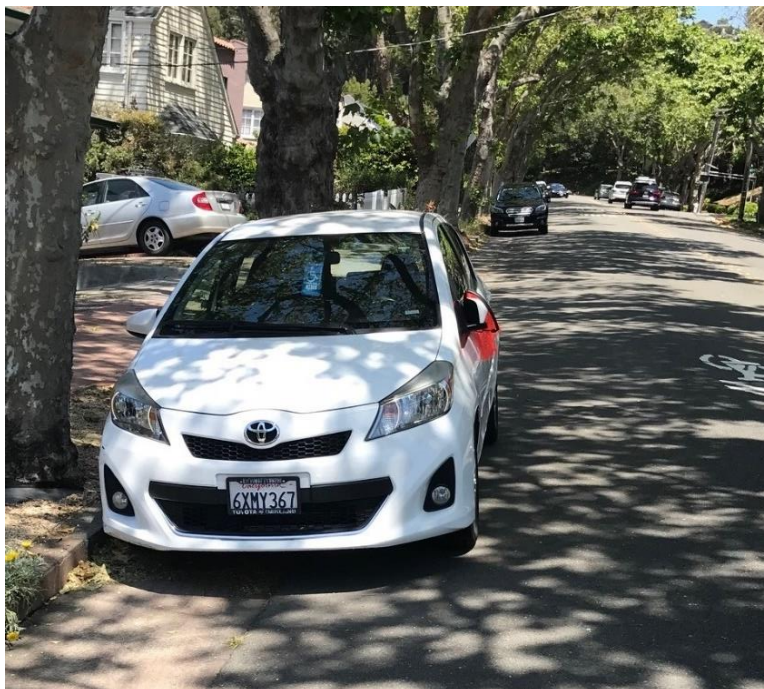
Figure 3: Vehicle with High Visibility Vest on Driver Side Mirror at Moraga Avenue and Mesa Avenue

- Vehicles parked on north side of Moraga Avenue near Mesa Avenue were observed with high visibility vests wrapped around their driver side mirrors (Figure 3).

The collision history confirms that this section of Moraga Avenue between Pala Avenue and Bonita Avenue has issues with drivers not adhering to lane discipline resulting in collisions with fixed objects and parked cars.

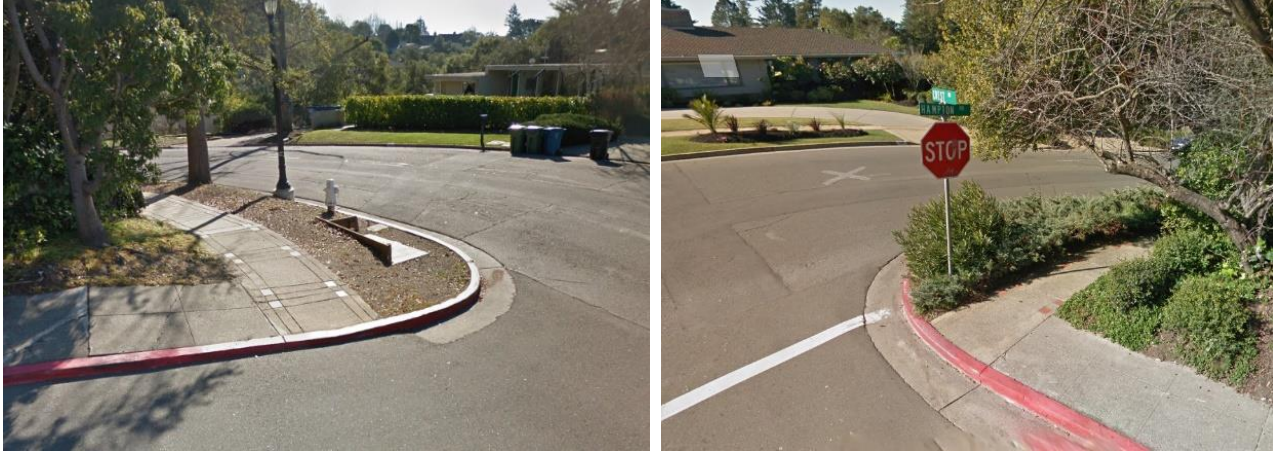
Figure 4: View to the left and right on Crest Road at Hampton Road

Crest Road intersects Hampton Road on both a horizontal and vertical curve, making sight distance challenging for the community. Kittelson reviewed this location to determine if it meets any of the four warrants that establish specific conditions where an all-way stop should be considered based on City Council Policy #31.

- Kittelson confirmed in the field that this intersection does not provide adequate visibility to maintain safe traffic operations to the west or east for drivers on Crest Road due to the vertical and horizontal curvature of Hampton Road. Therefore, all-way stop control should be considered based on Warrant 3 (sight distance).

- While the vehicle and pedestrian volumes and the collision history do not meet the warrants for an all-way stop control, the sight distance warrant (Warrant 3) is met. Therefore, changing this intersection to an all-way stop control should be considered.
- If the intersection is converted to an all-way stop control, crosswalk markings should be placed across each leg of the intersection as noted in City Council Policy #31 on crosswalks.
- If the intersection is not converted to an all-way stop controlled intersection, the vegetation on either side of Crest Road at this intersection should be removed to provide as much sight distance as possible.

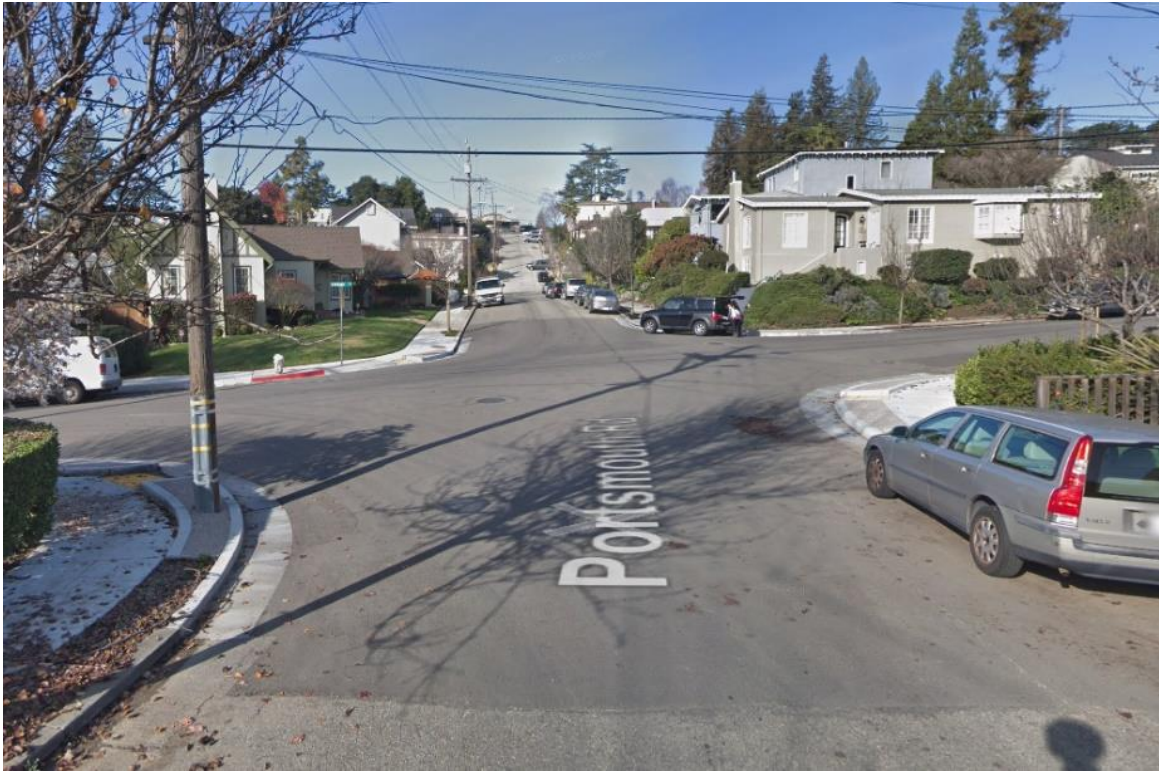
Figure 5: Portsmouth Street Looking North at Harvard Road

- Kittelson confirmed in the field that this intersection does not provide adequate visibility to maintain safe traffic operations:
 - Southbound Approach – Vegetation and parked vehicles restrict sight distance to the west.
 - Eastbound Approach – Vegetation and parked vehicles restrict sight distance to both the north and south.
 - Northbound Approach – Vegetation and parked vehicles restrict sight distance to both the east and west.
 - Westbound Approach – Vegetation and parked vehicles restrict sight distance to the north.

Therefore, the sight distance warrant for all-way stop control (Warrant 3) is met.

- While the vehicle and pedestrian volumes and the collision history do not meet the warrants for an all-way stop control, the sight distance warrant (Warrant 3) is met. Therefore, changing this intersection to an all-way stop control should be considered.
- Crosswalk markings should also be installed for all stop-controlled approaches to this intersection per City Council Policy #31.

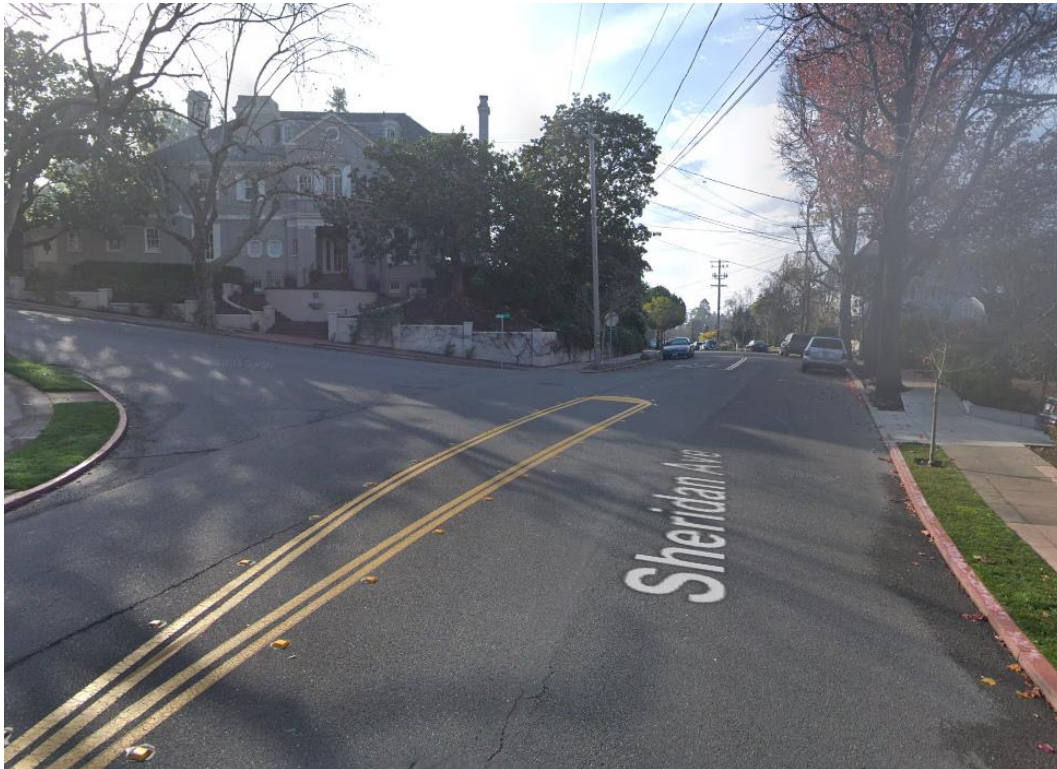
Figure 6: Sheridan Street Looking South at Lincoln Avenue

The intersection of Lincoln Avenue and Sheridan Avenue is a “T” intersection where the dominant traffic movement is between the north leg (Sheridan Avenue) and the east leg (Lincoln Avenue). Consequently, the south leg is controlled by a stop-sign while the north and east legs are uncontrolled. The community has expressed concerns about vehicle and pedestrian safety at this intersection.

- The intersection configuration is unusual since the major street changes from Sheridan Avenue to Lincoln Avenue at this intersection resulting in the northbound Sheridan Avenue approach being stop-controlled.
- Many drivers were observed to make the southbound left turn from Sheridan Avenue onto Lincoln Avenue by cutting across the painted median.
- The “STOP” legend in the street along with the crosswalk markings for the northbound approach have faded making them more difficult to see.

- There is insufficient vehicle and pedestrian traffic at this intersection to warrant the installation of all-way stop control. However, there are improvements that can be made at this intersection to improve circulation for all users. These improvements include:

- Remove the painted median and restripe the centerline on both Lincoln Avenue and Sheridan Avenue to better define the roadway.
 - Using Detail 41 striping, connect the centerline on the north leg of Sheridan Avenue with the centerline on Lincoln Avenue to better direct vehicles around the curve.

- Restripe the “STOP” pavement legend and the marked crosswalk for the stop-controlled approach.
- Since the pedestrian volumes are less than 20 pedestrians per hour, a crosswalk across Lincoln Avenue at this intersection is not suggested based on City Council Policy #31. If a pedestrian crosswalk at this location were to be installed, substantial changes to the intersection should be made due to the wide throat of Lincoln Avenue at Sheridan Avenue and the decreased sight distance for vehicles traveling around the curve. These changes may include:

- Narrowing the Lincoln Avenue approach and modifying it to connect with Sheridan Avenue at a 90-degree angle. This could be accomplished with on-street painted markings, but vehicle compliance would likely be low. Therefore, hardscape improvements would be recommended.

- While the warrant is not met, an all-way stop control intersection would be suggested if hardscape improvements are implemented to better separate vehicle and pedestrian movements at the smaller intersection form.

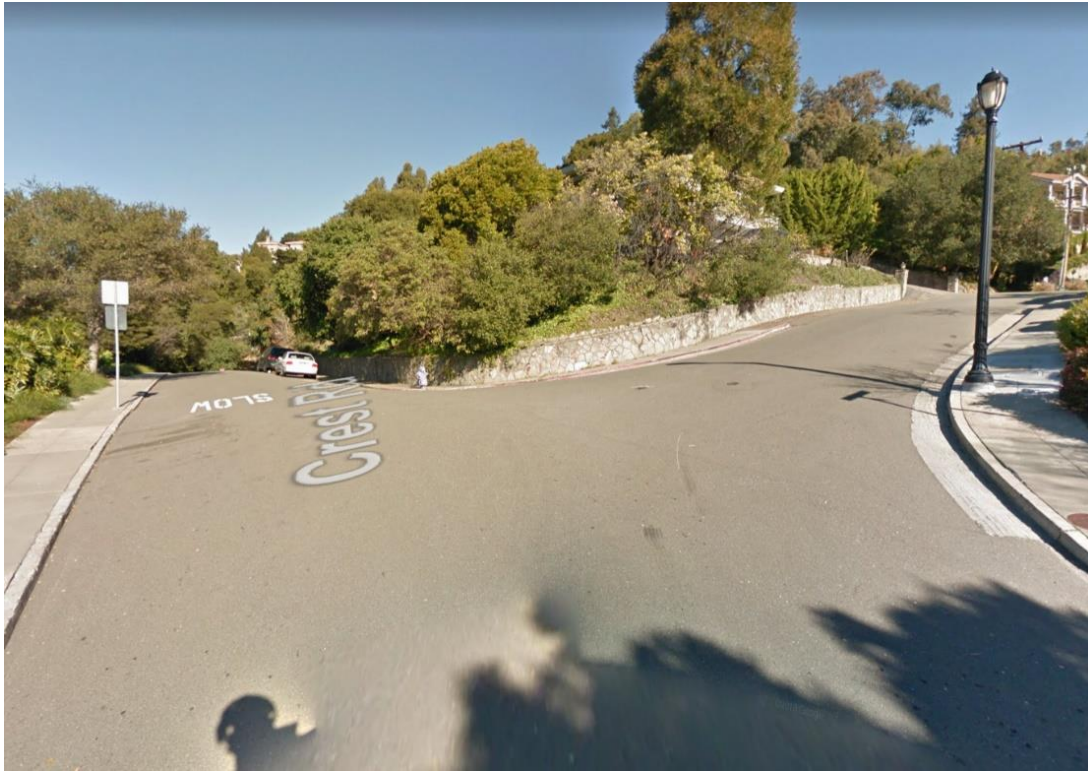
Figure 7: Crest Road Looking North Towards Somerset Road

The intersection of Crest Road and Somerset Road does not currently have stop or yield signs posted on any of the approaches. The community has expressed concern over the assignment of right of way at this intersection and reduced visibility on the approaches.

- Kittelson confirmed in the field that Somerset Road does not provide adequate visibility to maintain safe traffic operations when looking north due to a retaining wall and vegetation. Therefore, all-way stop control at this intersection should be considered because it meets the sight distance warrant (Warrant 3).

- Install an all-way stop control intersection at this location based on meeting the conditions described in Warrant 3 for inadequate sight distance.
- Crosswalk markings should also be installed for all stop-controlled approaches to this intersection per City Council Policy #31.
